# Turnkey Tube Cleaning and Liner Installation in Six Days!

### A Gulf Coast refinery called Curran to support restoration of in-service air coolers, during a short maintenance pit stop.

## Curran Helps Keep Fresh Water Flowing Desalination/Power Plant Condenser Refurbishment

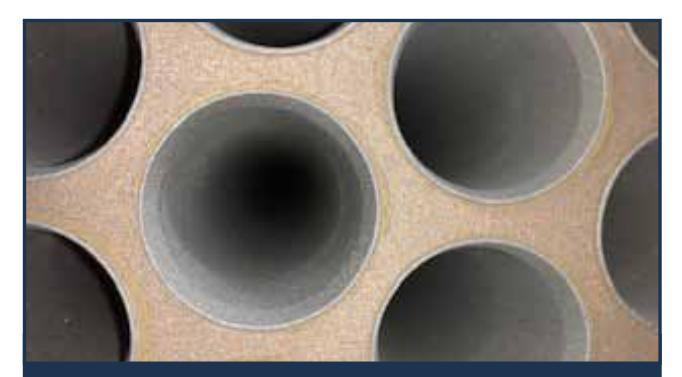
Surface prepped tubes and tubesheets

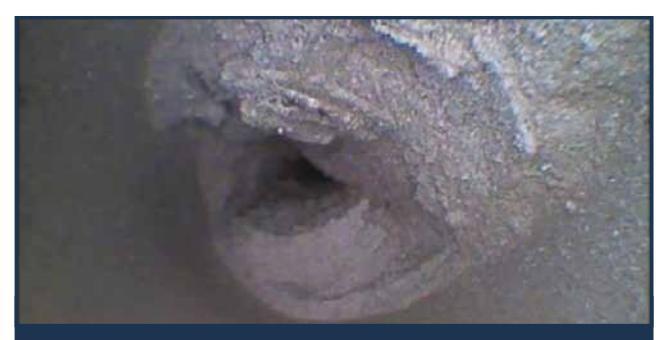
Before the tubes could be coated, they needed to be dried of residual channel water. While drying the tubes, several tubes were found to have had severe mineral fouling and were plugged. These tubes required hydro-lancing.

Cooling water scale plugged tube required hydrolancing to clear it before grit-blasting for coating.
